Technical Memorandum
Soil Resource Evaluation Pilot Study
Task Order #40
(Construction Report and Evaluation)

December 2008

CTSW-TM-08-172.40.1

California Department of Transportation
Division of Environmental Analysis
Storm Water Program MS27
1120 N Street, Sacramento, CA 95814

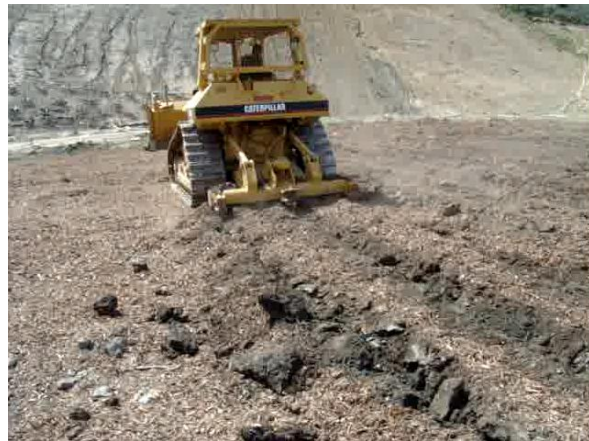
- a. Contour Rip Method: A Caterpillar D-6 track dozer with 36-inch long ripping teeth was initially used to rip the onsite soils and incorporate amendments into the soils. The ripping pattern generally consisted of equipment passes approximately 3 feet apart, roughly parallel to the toe of the slope (*see photo 2*). This method incorporated some amendments into the soil but not as effectively as desired by the project team members. In particular, the organics materials did not get mixed

more than 18 to 24 inches into the soil and the lateral movement of loose soil caused by crabbing of the tractor created uneven distribution of loose organics into the soil profile. Therefore, additional treatments were developed on site.

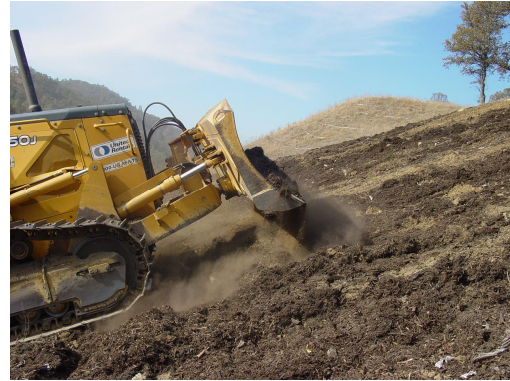
- b. Bench Fill Method: During the *Amendment Incorporation* steps as described in this Section 5.4.2.c, the geotechnical consultant recommended that the interface between the amended soils and underlying natural soils should not be parallel to the existing slope face so that a slip plane was not created that would easily fail. Therefore, the base of the volumes with incorporated amendments should rest on a horizontal base, resulting in an undulating interface that is keyed into the undisturbed slope material. To address this recommendation, an additional method of incorporation was developed that consisted of a D-6 dozer that passes, roughly perpendicular to the toe of the slope, traveling vertically up-slope. The dozer excavated the soil surface in an undulating manner by raising and lowering the blade as the dozer progressed up the slope face. The resultant excavated slope areas were approximately 2 to 3 feet deep and were spaced approximately 8 to 10 feet apart vertically on the slope surface. This method thoroughly mixed and incorporated the amendments into the soil profile to the recommended 3 foot depth as desired by the project team. During the descents, the dozer lowered its blade and

smoothed the slope surface back to its original configuration. The descents also resulted in additional mixing of the amendments into the soil. This technique resulted in a high degree of amendment incorporation acceptable to the project team. This technique is shown on *Photo 3*. This method represents the “bench” method in which the tilled or mixed materials rest on a more or less horizontal bench to resist lateral movement when wet.

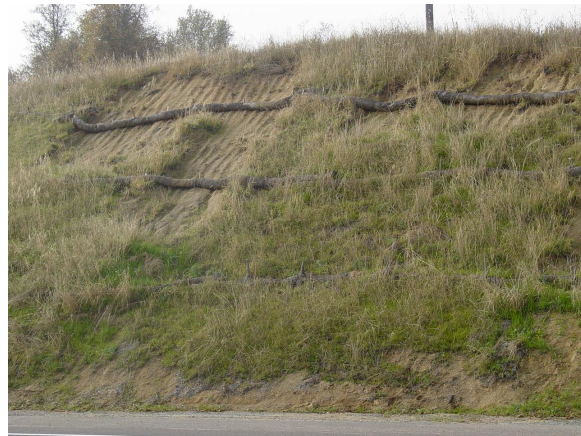
The “*Lotus Site*” is located at PM 24 -24.5 on Highway 49 in El Dorado County. The site consists of a generally northeast-facing cut slope excavated during widening of this section of the highway. The slope is located along the southwesterly side of the highway (see *Photo 6*). The slope is approximately 400 feet long, attains a maximum height of approximately 45 feet, with a maximum slope inclination of approximately 1.5 to 1 (horizontal to vertical). The original revegetation efforts, consisting of hydroseeding with a native species seed mix, subsequent to excavation of this slope have been deemed generally ineffective. The slope face experienced minimal plant germination, shallow rooting depths, indications of downslope soil erosion, and several localized areas of fairly shallow surficial slope slumping. There also was an accumulation of eroded soils at the toe of the slope along the edge of the roadway.

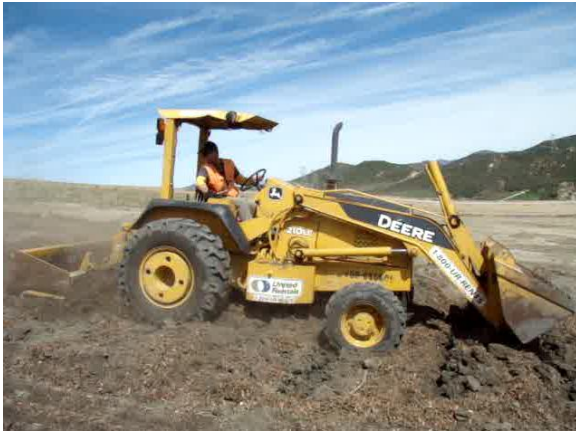
A D-6 Track Dozer with 36-inch ripping teeth was used to horizontally rip and incorporate soil amendments from 24 to 36 inches deep into the soil profile for the entire project area. This method work well at breaking up the soil, but did not get enough amendment blended throughout the soil profile. Therefore, the site was also cross ripped using a skip loader with 12 inch ripping teeth that mixed and incorporated the amendments throughout the soil profile to the satisfaction of the project team. Subsequently, the skip loader conducted final passes over the site to flatten the larger rows created by the skip loader's initial passes and finished the soil surface with small 4-inch furrows that were horizontal to the bottom of the slope (*see photo 12*). These 4-inch furrows acted as diversions to eliminate potential negative effects of downslope surficial water runoff.
